Service Bulletin

Checking of elevator trim cable assembly

Applicability: All EuroFOX aircraft operating under a UK LAA or BMAA administered Permit to Fly.

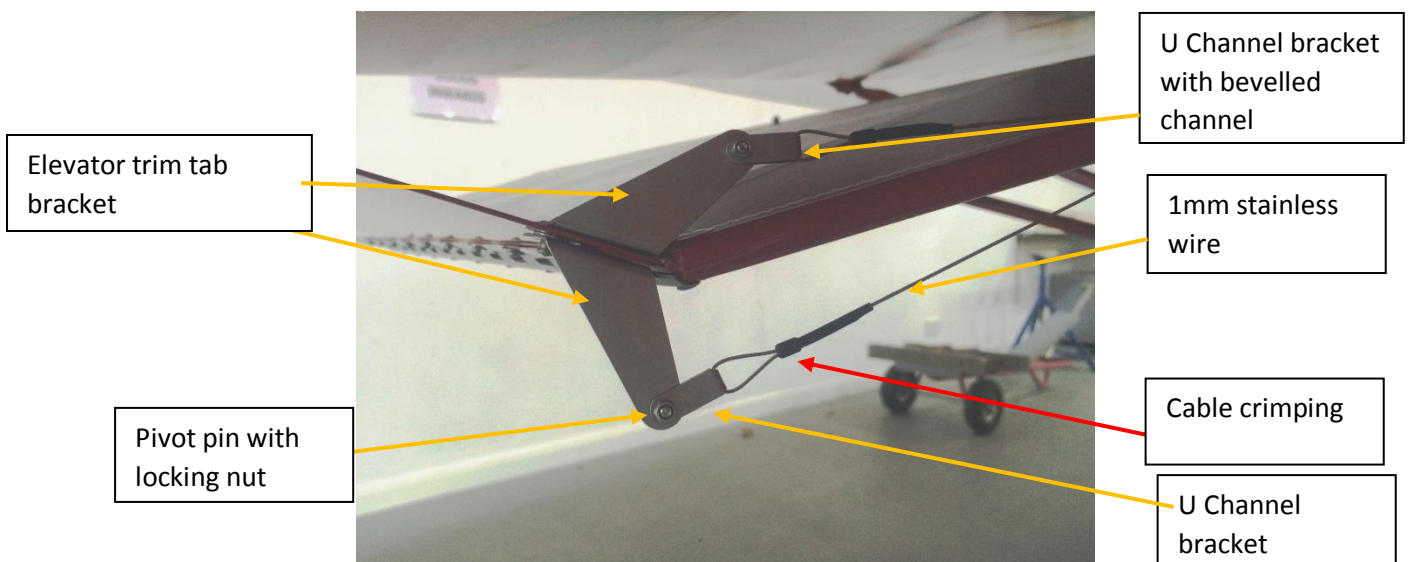
View of the elevator trim cable assembly

The cable runs through the U clamp and acts as a single unit rotating around the pivot pin, the wire does not rotate around the U channel so there is no wear. If the pivot pin become stiff or seized the U Channel will be prevented from rotating, the wire will rotate around the U channel bracket and wire wear with cable fraying will eventually occur. The links below will download videos that will show how the system is designed to work.

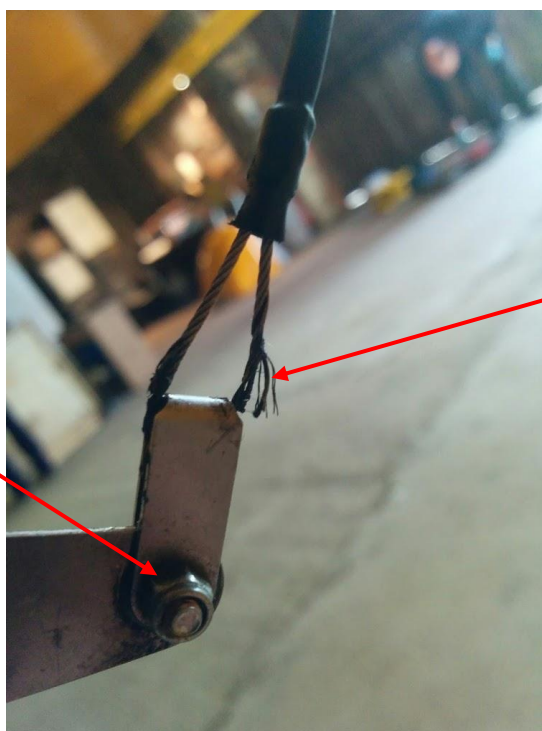
In one particular 800 hours high use aircraft with many 1000's of take-off/landing cycles, it was noted that the trim cable had started to fray. This aircraft had not been maintained in a methodical and systematic manner and in line with published maintenance and lubrication guidelines. This SB is to remind and inform owner/operators that this is an area to pay attention to and the photo below shows a good example of cable fraying and what may happen if regular detailed inspection and maintenance is not performed.

Seized pivot pin due to corrosion, lack of lubrication or pivot pin and nut with too much torque on initial build

Frayed cable as its been rotating around the U channel due to pivot pin seizure

The elevator trim cable is part of the 100 hour inspection and lubrication schedule for the aircraft, this SB is to remind all owners to comply with this and make additional inspections if deemed fit or the aircraft is operated/stored in a particularly harsh environment.

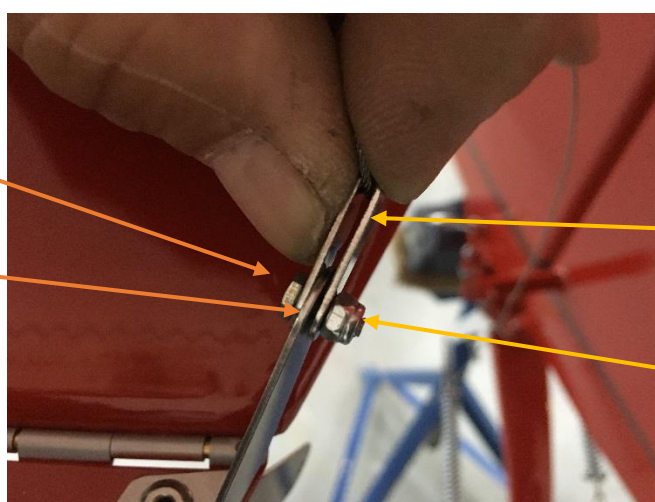
View of the U Channel and pivot pin assembly

Pivot pin

Important to maintain a gap and free rotation here

U Channel with wire guide bevel recess to allow cable to seat

Locking nut

1. Ensure the U clamp has sufficient clearance to allow the assembly to freely rotate around the pivot pin
2. Ensure the pivot pin nut is not tightened so as to reduce the clearance in the U channel which restricts movement
3. Ensure on initial build that the crimp in the stainless wire is not too close to the U bracket and the U channel is free from any burrs where the 1mm wire locates inside the bevelled end.
4. Keep the pivot pin assembly free from dirt, debris and any corrosion by using a suitable grease lubricant or ACF 50
5. Ensure that the 1mm cable ends (loops) are inspected for fraying and replaced if there is any evidence of such
