Service Bulletin

Checking of elevator trim cable assembly

Applicability: All EuroFOX aircraft operating under a UK LAA or BMAA administered Permit to Fly.

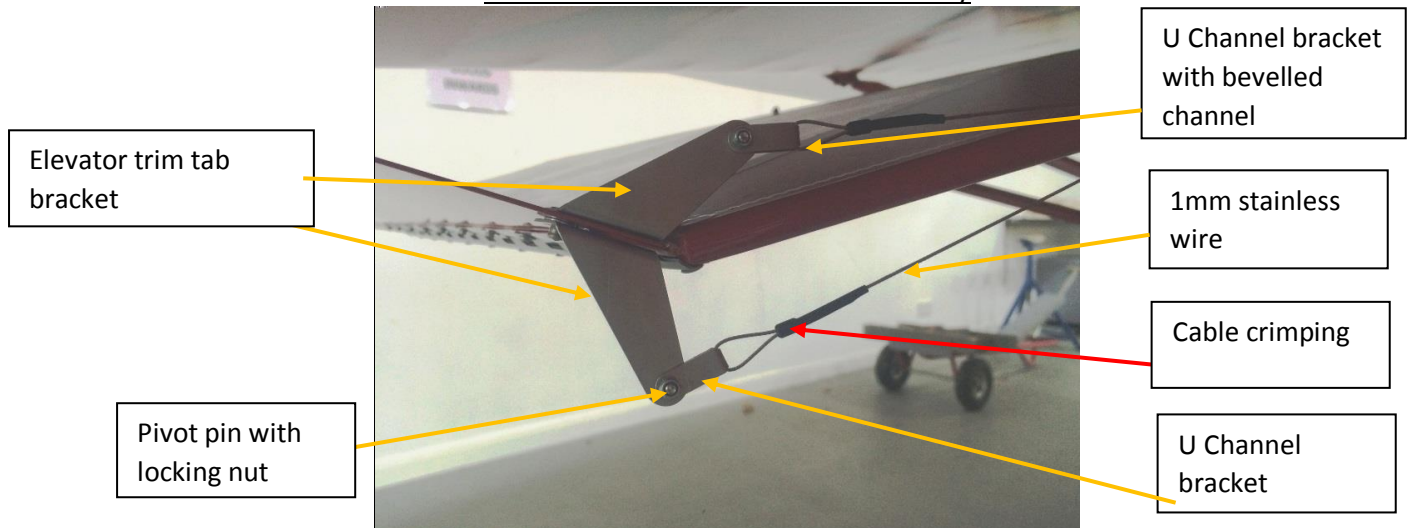
View of the elevator trim cable assembly

The cable runs through the U clamp and acts as a single unit rotating around the pivot pin, the wire does not rotate around the U channel so there is no wear. If the pivot pin become stiff or seized the U Channel will be prevented from rotating, the wire will rotate around the U channel bracket and wire wear with cable fraying will eventually occur. The links below will download videos that will show how the system is designed to work.

1. Ensure the U clamp has sufficient clearance to allow the assembly to freely rotate around the pivot pin
2. Ensure the pivot pin nut is not tightened so as to reduce the clearance in the U channel which restricts movement
3. Ensure on initial build that the crimp in the stainless wire is not too close to the U bracket and the U channel is free from any burrs where the 1mm wire locates inside the bevelled end.
4. Keep the pivot pin assembly free from dirt, debris and any corrosion by using a suitable grease lubricant or ACF 50
5. Ensure that the 1mm cable ends (loops) are inspected for fraying and replaced if there is any evidence of such

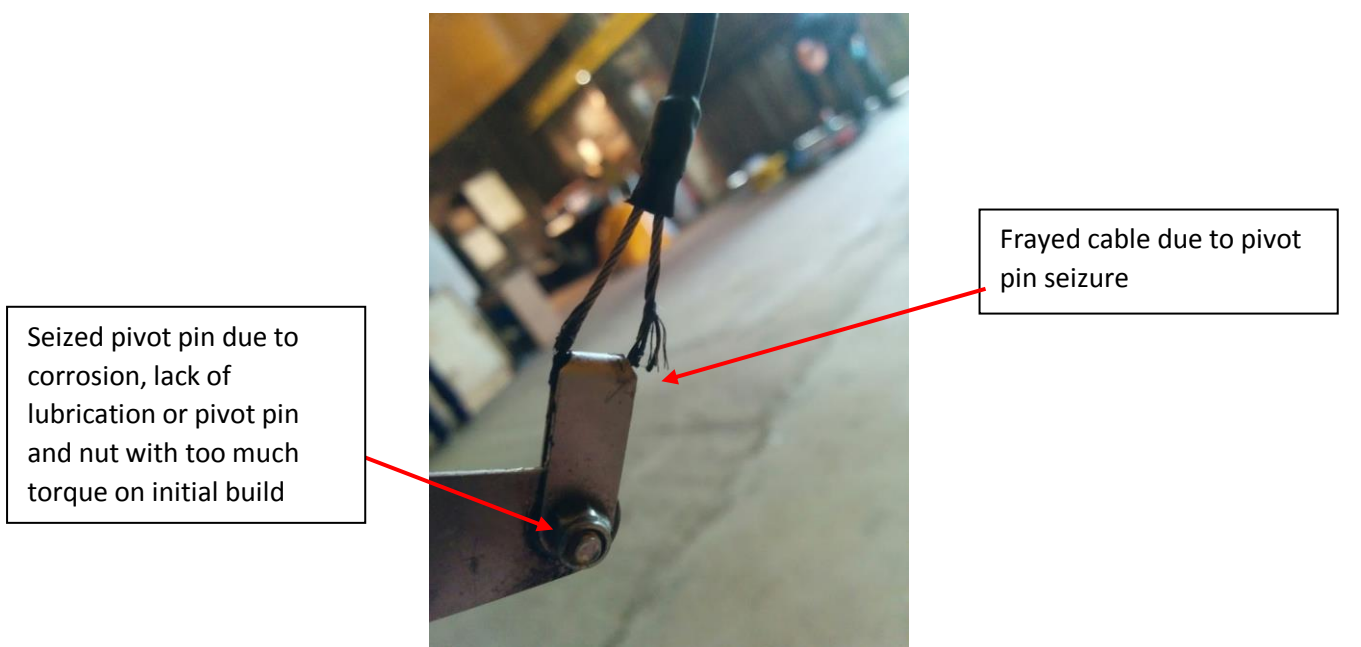
In one particular 800 hours high use aircraft with many 1000's of take-off/landing cycles, it was noted that the trim cable had started to fray. This aircraft had not been maintained in a methodical and systematic manner and in line with published maintenance and lubrication guidelines. This SB is to remind and inform owner/operators that this is an area to pay attention to and the photo below shows a good example of cable fraying and what may happen if regular detailed inspection and maintenance is not performed.

This example illustrates the cable being forced through a 90 degree change over a short distance and that if the pivot point is seized there will be an angular movement of the cable each time the trim is operated ... this will, and has, work hardened (fatigued) the individual strands which has eventually, albeit after many cycles, led to cable failure.

The elevator trim cable is part of the 100 hour inspection and lubrication schedule for the aircraft, this SB is to remind all owners to comply with this and make additional inspections if deemed fit or the aircraft is operated/stored in a particularly harsh environment.
