Service Bulletin

Inspection of Undercarriage Guide Bracket Bolt

Applicability: All EuroFOX aircraft operating under a UK LAA or BMAA administered Permit to Fly.

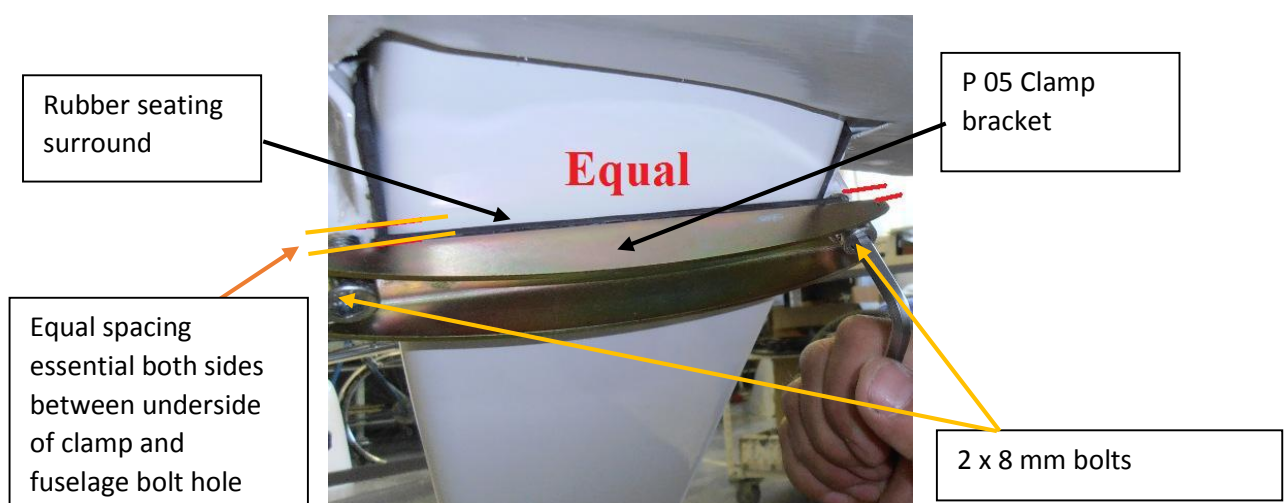
Background: During a routine daily inspection, an LAA EuroFOX pilot noticed that the hex drive head from one of the two bolts holding the undercarriage leg clamp bracket was missing, the bolt was therefore no longer securing this side of the clamp bracket. A subsequent examination of the fracture face of this bolt suggested that the bolt had been over-tightened when initially fitted; a review of the build instruction manual showed that early issues of the build manual didn't clearly describe the tightening procedure for this bolt.

View of the undercarriage clamp bracket assembly

Actions required for compliance: Later editions of the EuroFOX build Manual describes the method for installing these clamp bolts, suggesting that, **'care should be taken not to over-tighten these M8 bolts. The bolt needs to be just 'nipped-up' to settle onto the rubber surround'**. If the aircraft's maintainer is certain that the clamp bolts have been installed correctly then only an initial in-situ inspection for serviceability needs to be completed. If the aircraft's maintainer is unsure about the initial fitting procedure, the wire locking needs to be snipped and the bolt's torque established: if the bolt has been installed correctly, a gentle force will undo it, if this is the case then the bolt should be inspected for serviceability, re 'nipped-up' and re-wire locked. If the bolt has been tightened down excessively then it is likely that the bolt(s) will have been damaged and all four bolts must be replaced at the earliest opportunity.
