Title: EuroFOX SB 03/2016 LAA (v2)

# **Service Bulletin**

## Replacement of Undercarriage Guide Bracket Bolts

**Applicability:** All EuroFOX tail dragger aircraft operating under a UK LAA administered Permit to Fly.

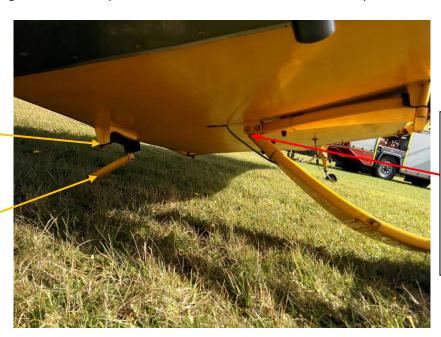
Clamp bracket

On a EuroFOX heavy use tail wheel glider tug aircraft with tundra tyres, the forward bolt failed on the undercarriage clamp bracket (containing 2 bolts M8 hex head 8.8 strength). The clamp bracket then swung away from the undercarriage leg just after take-off, and the leg itself being unrestrained, pivoted about its central fixing point in the middle and underside of the fuselage. A successful and very skilled landing was made on one leg and the tail wheel, with minimal damage.

On inspection, it became apparent that the bolt had failed in fatigue just under the bolt head. The fatigue crack had been present for a while, but is not easy to find during normal inspections. The earlier SB on this subject (SB2 2015) did not prevent this failure, therefore to minimise risk, it is required to change the assembly method and "life" of this bolt. The new fixing method will improve the load transfer within the assembly.

Broken bolt allowing the guide bracket to swing away and release the U/C leg

Pivot point on the tail dragger U/C leg. When released by the clamp bracket, the leg can swing freely away

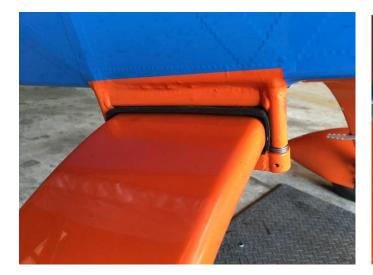
#### Finished assembly below with washers fitted (shown prior to split pin fitted)

Production tolerances mean that in very rare cases 4 washers may be needed on one side of the clamp bracket – the SB pack contains 7 washers in case. However, the aircraft fitted to date did not show this requirement.
