Service Bulletin

Replacement of Undercarriage Guide Bracket Bolts

Applicability: All EuroFOX **tail dragger** aircraft operating under a UK BMAA administered Permit to Fly microlights.

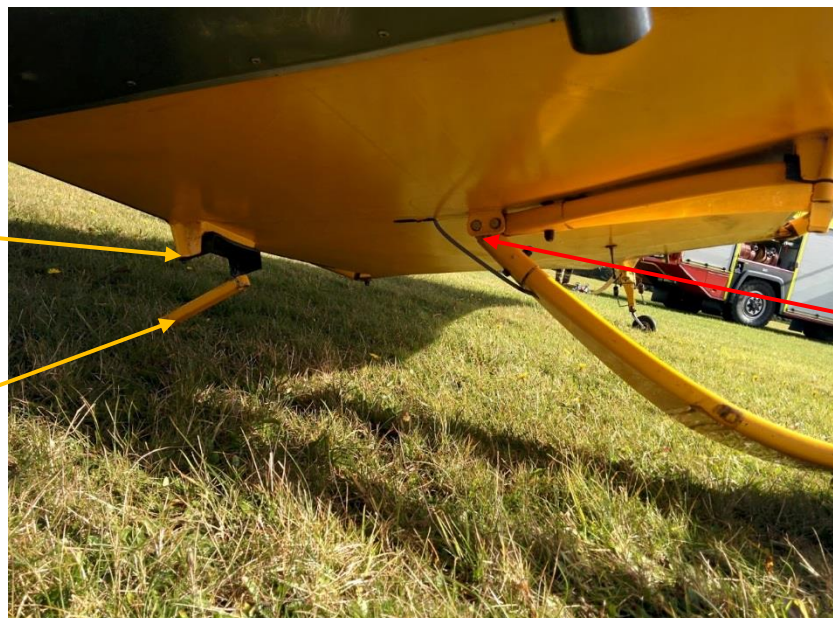
On a EuroFOX heavy use tail wheel glider tug aircraft with tundra tyres, the forward bolt failed on the undercarriage clamp bracket (containing 2 bolts M8 hex head 8.8 strength). The clamp bracket then swung away from the undercarriage leg just after take-off, and the leg itself being unrestrained, pivoted about its central fixing point in the middle and underside of the fuselage. A successful and very skilled landing was made on one leg and the tail wheel, with minimal damage.

On inspection, it became apparent that the bolt had failed in fatigue just under the bolt head. The fatigue crack had been present for a while, but is not easy to find during normal inspections. The earlier SB on this subject (SB2 2015) did not prevent this failure, therefore to minimise risk, it is required to change the assembly method and “life” of this bolt.

Broken bolt allowing the guide bracket to swing away and release the U/C leg

Clamp bracket

Pivot point on the tail dragger U/C leg. When released by the clamp bracket, the leg can swing freely away

Actions required for compliance: If the aircraft has completed more than 500 hours, or 1000 landings, a mandatory replacement of these bolts using the new fitting instructions as below is required. Aircraft with less than these hours or landings, can replace their bolt assemblies optionally.

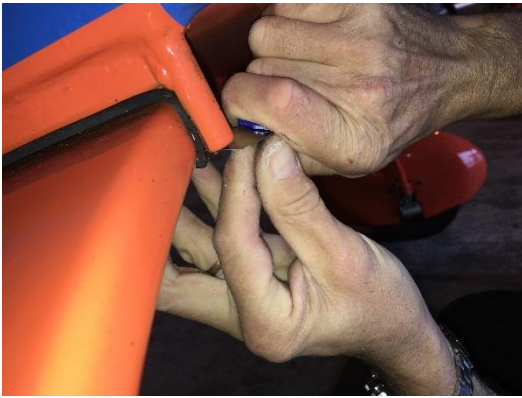
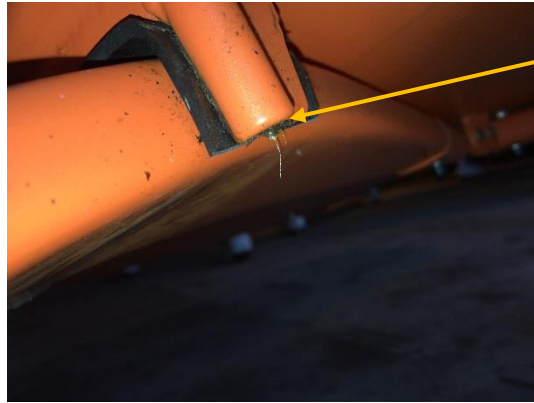
No rubber should obstruct this face

4. Trim the top fuselage rubber so that it is flush with bracket end as shown, so rubber does not foul new washer. Also ensure the top rubber is evenly and centrally positioned around the leg. Contact EuroFOX Aviation if you need new rubbers
